## SEISMIC EVALUATION OF CITY OF SALEM CIVIC HALL

JOB NUMBER: 160649

## Executive Summary

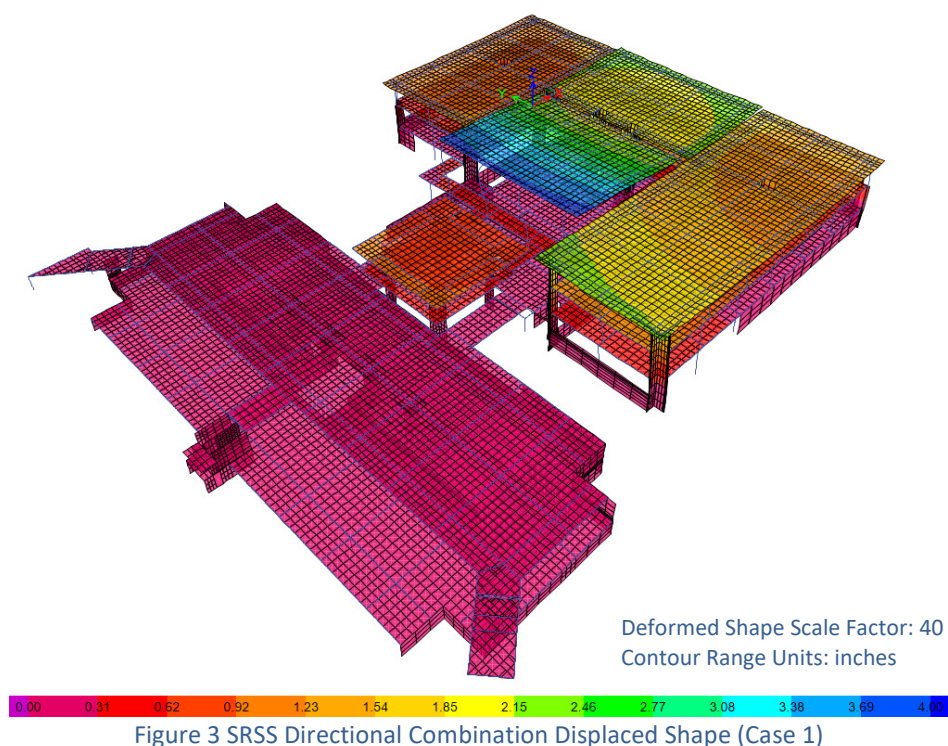
Figure 3 presents the deformed shape of the structure under seismic loading after combining the displacements using the Square Root of the Sum of the Squares (SRSS) directional combination procedure.

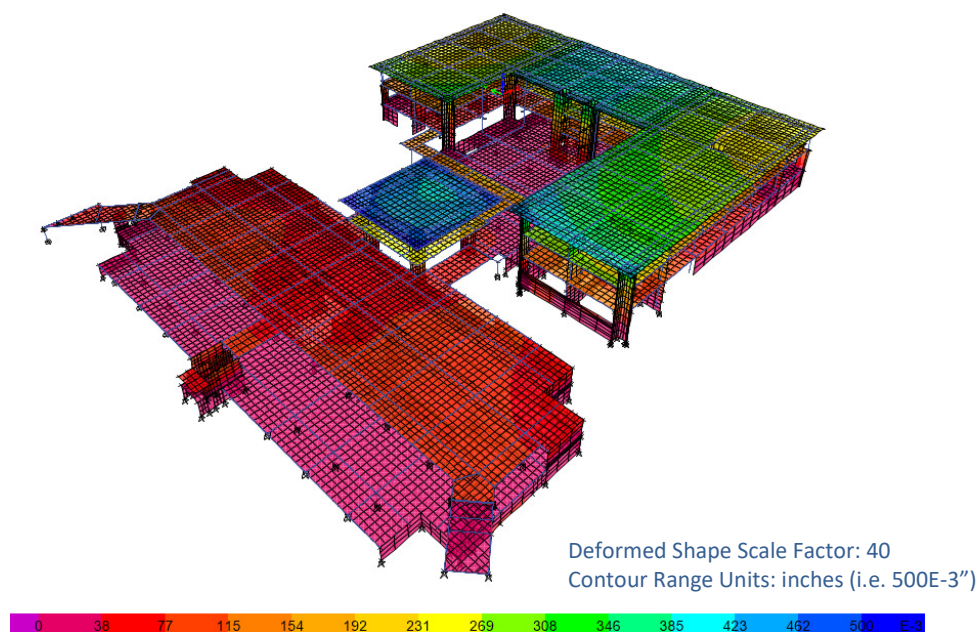
Figure 11 SRSS Directional Combination Displaced Shape

Table 9 shows that the magnitude of inelastic displacement at the roof level in the East wing decreased by 27% and by 41% at the South wing. Tying the wings together result in a substantial reduction in the level of stress at shearwall piers and columns. Also, reducing the deformation eliminates the possibility of impact and the falling of hazards such as spalling concrete between floor plate interfaces. Figure 11 illustrates the deformed shape of the structures under seismic loading after combining the displacements using the Square Root of the Sum of the Squares (SRSS) directional combination procedure.
