## DECISION OF THE PLANNING ADMINISTRATOR

**CLASS 3 SITE PLAN REVIEW / CLASS 2 ADJUSTMENT / TREE REGULATION  
VARIANCE CASE NO.: SPR-ADJ-TRV22-36**

**SUMMARY:** Proposed development of a Vietnam War Memorial.

**Tree Risk Assessment Report**  
The Embracing Tree  
Willson Park, Oregon State Capitol  
May 25, 2022

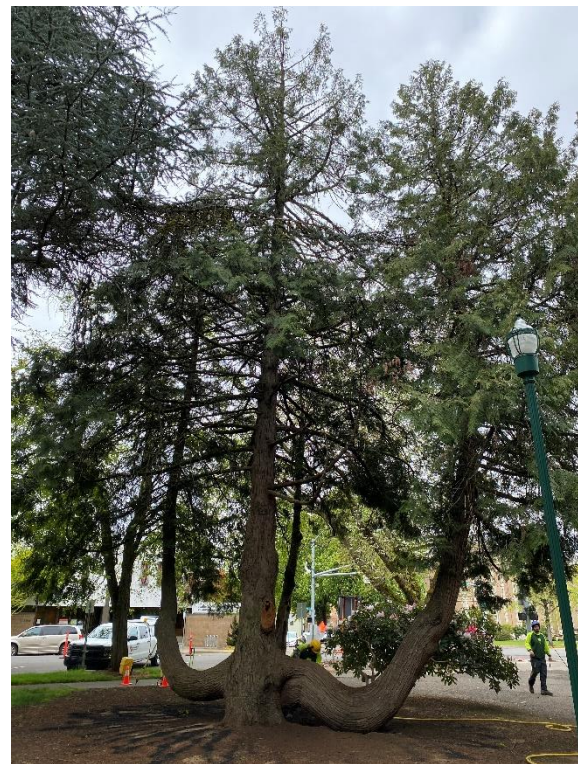
**Photo 1.** The Embracing Tree during Root Invigoration procedure. (04.29.2022)

The Embracing Tree was assessed and the root system was surveyed in April 2022 in conjunction with a Root Invigoration™ performed by Bartlett Tree Experts. The root collar of the Liberty Tree was also exposed and surveyed. The purpose of the survey was to locate the significant roots (those two inches in diameter and larger), and more importantly, the spaces between them to aid in determining where footings could be placed to support a deck, which will encompass much of the root zone of the Embracing Tree. The deck will be elevated, avoiding contact with the ground, which will avoid future interactions with tree roots. Outward to the northeast from the deck, a patio of permeable concrete pavers will be laid through the remainder of the Embracing Tree's root zone and that of the Liberty Tree. Rainwater will be allowed to penetrate through the patio surface, down to the roots of the two trees.

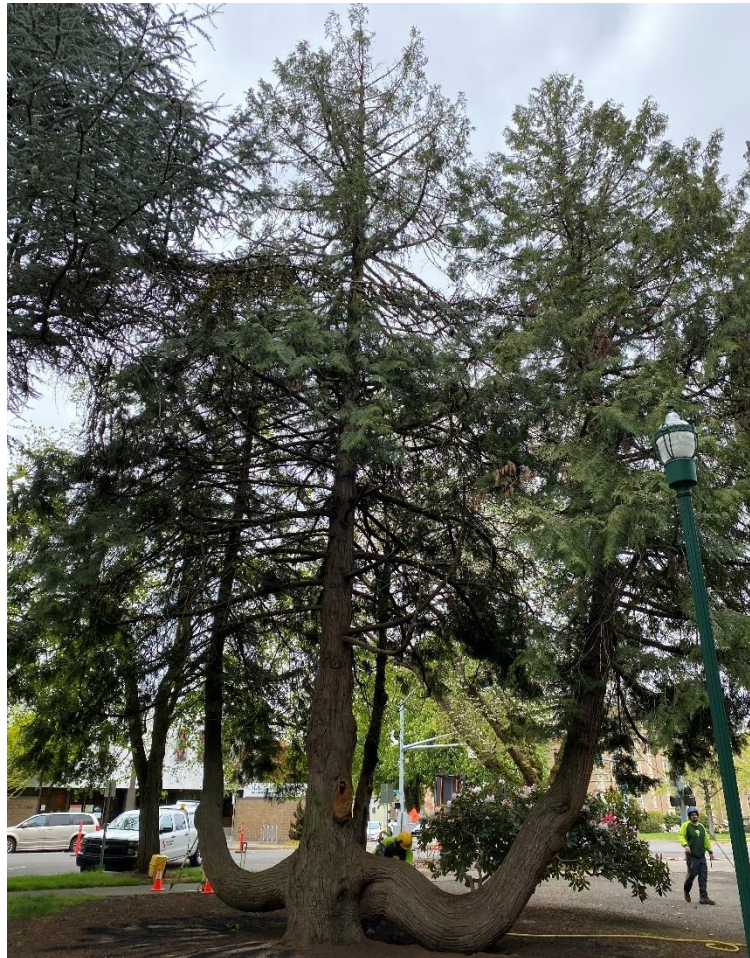
ArborSonic 3D™ tomograms indicated the presence of a significant loss of structural integrity at all three sensor planes on the central stem. A minor loss of structural integrity was detected at the sensor plane closest to the site of an open cavity on each of the secondary “arms,” with negligible loss of structural integrity at the sensor plane located 150cm out on each arm from its union with the central stem. The loss of structural integrity in the central stem appeared somewhat asymmetrical and lacked any visible external indicators, except the general decline of the central stem's foliar canopy and a cavity in the cross section of a large branch that had previously been removed. Using the methods outlined in this report and the results of the assessment of this tree, it is my professional judgment that the overall risk rating for root collar, trunk, crown, and branch failure is **low** within the next three years.

**Photo 1:** The Embracing Tree as seen from the northeast, showing its unique structure. (04.29.2022)

- Option One:  
I recommend pruning to remove dead branches and reduce the relative size of the crown. The estimated residual risk of root collar, trunk, crown, or branch failure would remain *low*.
- Option Two:  
If the level of risk is unacceptable, then the tree should be removed and the stump ground, removing all risk of failures associated with the tree.
- Option Three:  
If no mitigation is done, the overall risk rating would remain low. The tree's risk may increase in the future as a result of not performing mitigation.

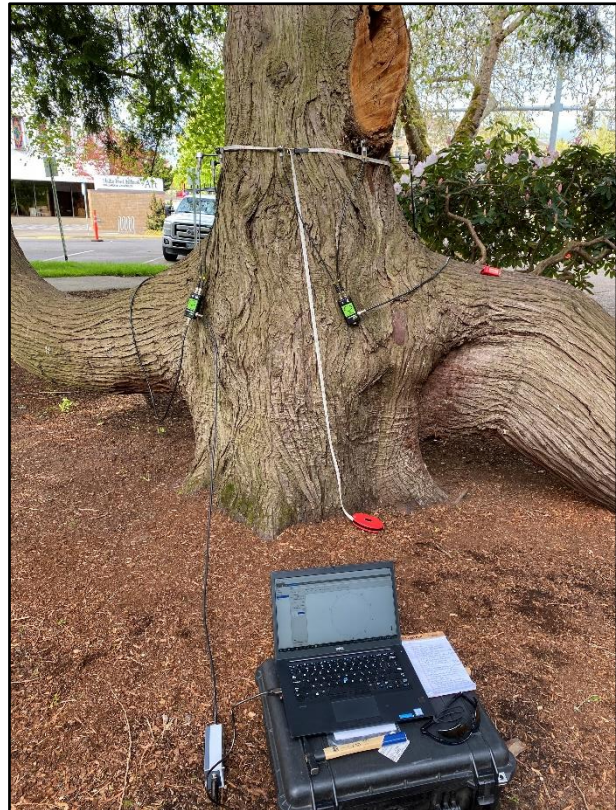
**Photo 2:** Sonic tomography readings were taken on three horizontal planes of the redcedar's central stem, and on two vertical planes on each of the two secondary stems. Significant loss of structural integrity was indicated at all three central sensor planes, and minor to negligible loss of structural integrity was detected at the four secondary sensor planes. (04.29.2022)

The tree was in fair condition. The loss of structural integrity detected within the lower trunk was significant. A visual representation of sonic tomography data showed a continuous column of loss of structural integrity between the upper and lower sensor planes that was fairly irregular in shape.

While the shell wall thickness to the east and west of the column was adequate for support, the asymmetrical shape of the column may increase the likelihood of trunk failure. Because all three stems were cabled, failure of one stem could cause a domino effect, resulting in one or both remaining stems failing.

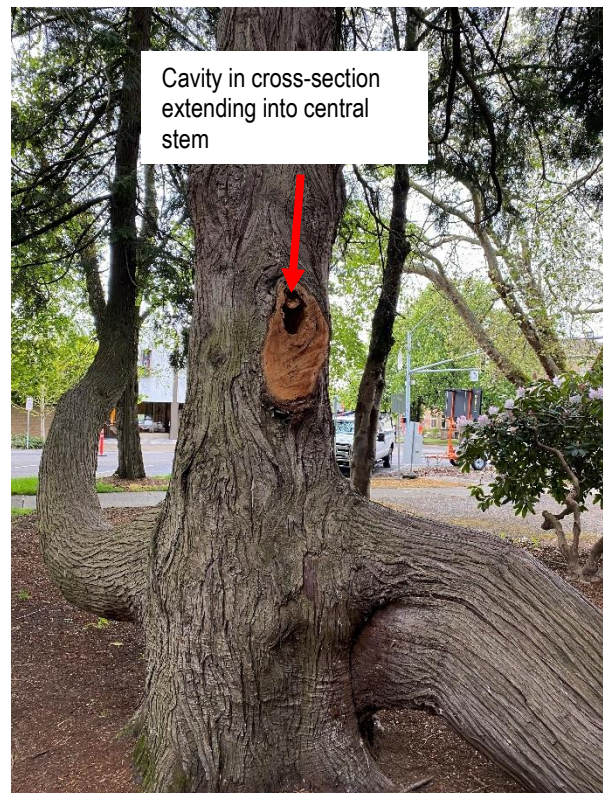
Above and slightly offset from the union of the central stem with the northeasterly secondary stem was a cut approximately 20 inches high by 12 inches wide that had removed a large branch. It appeared to be about a year old, possibly also the result of a storm damage induced failure from February 2021. The top of the cut had a cavity roughly 5.5 inches in diameter (Photo 3). The cavity appeared to extend into the central stem, based on the hollow sound I observed when I struck the area with the mallet. The readings obtained with the ArborSonic® at the upper sensor plane appeared to support my observation.

**Photo 3:** A large branch was removed prior to our assessment, revealing a cavity that extended into the central stem. (04.29.2022)

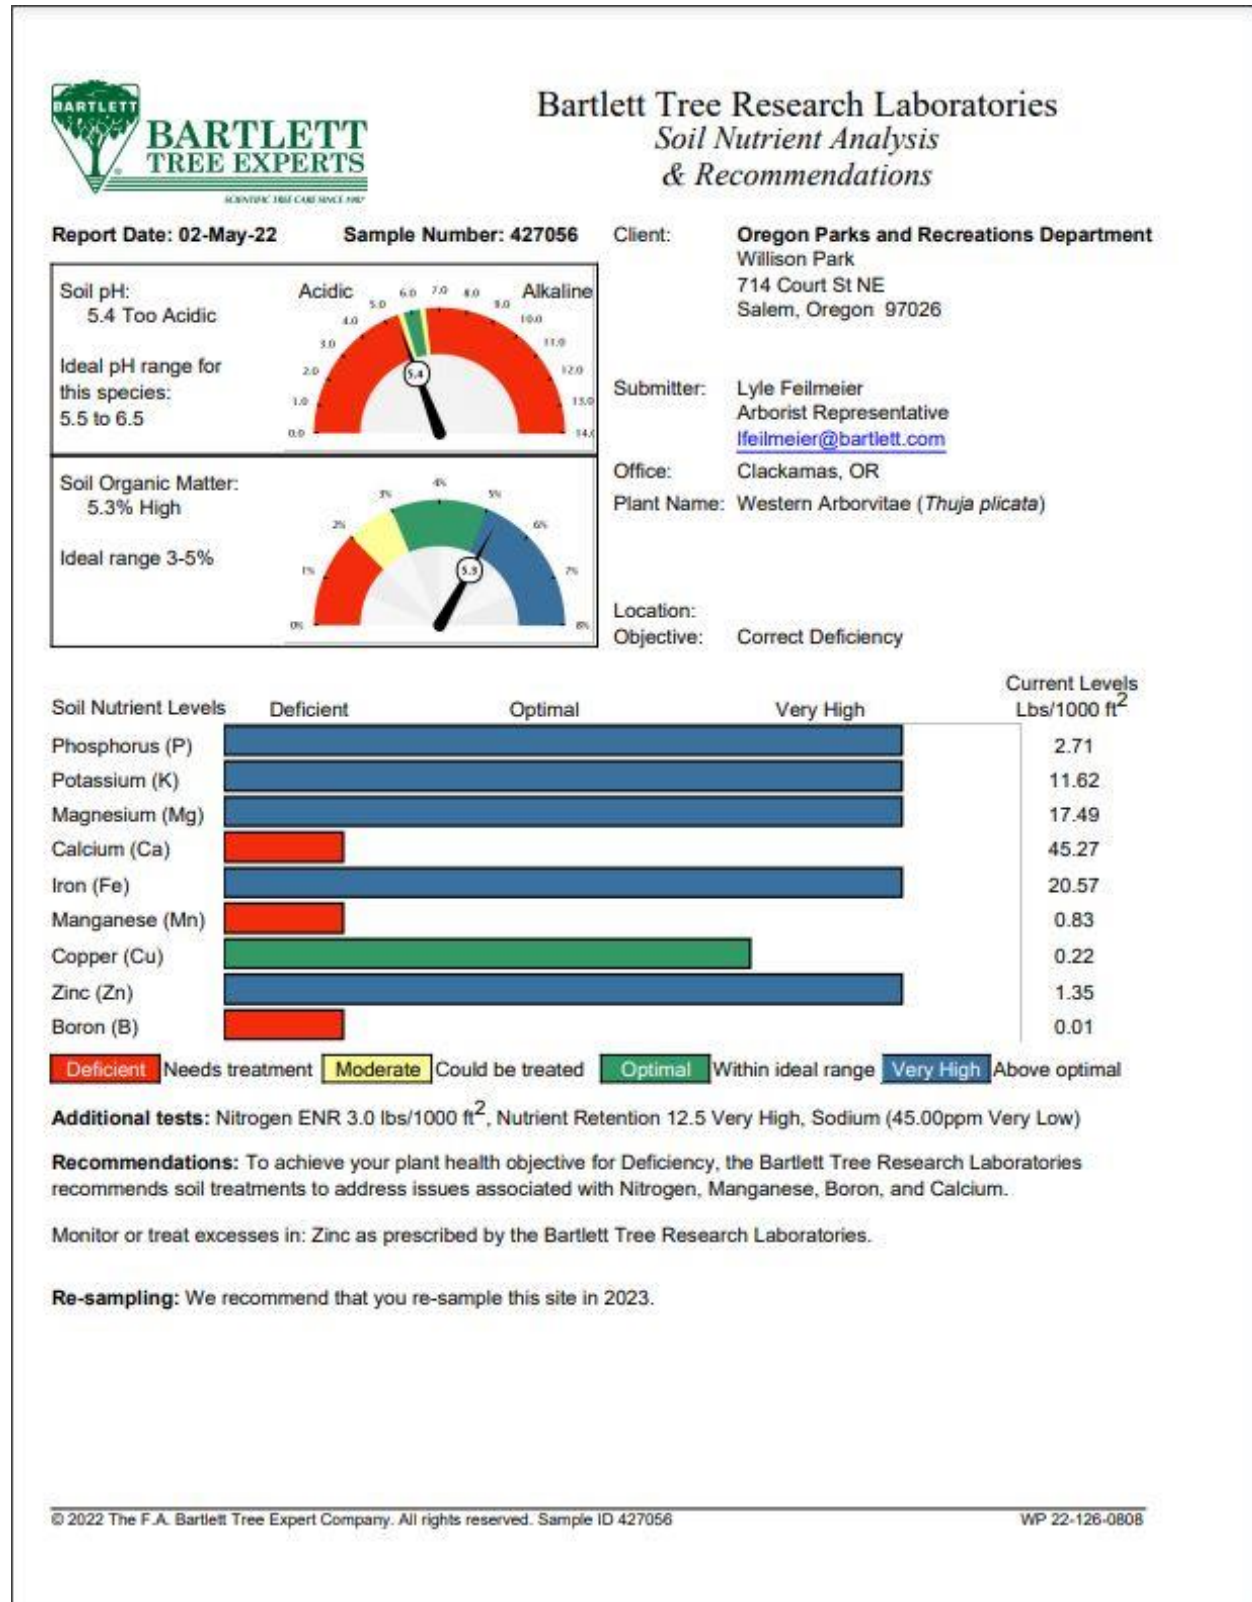
## Soil Nutrient Analysis Results

Laboratory results from the soil sample I took revealed a measured pH of 5.3, which is below the 5.5 minimum threshold of the preferred range for western redcedar. Boron, calcium, and manganese were also found in lower than recommended concentrations for the species. A copy of the results can be found in the appendix.

Soil and root samples were taken, to assess nutrition and to test for root rot pathogens. I recommend supplementing the nutrients found to be in short supply by the soil analysis and establishing a soil care program to curtail the further development of the Phytophthora infection discovered in the root sample.
